NASA CR-132611  
ARDE J/N 41004

FINAL REPORT  
FABRICATION AND TESTING OF  
PRESTRESSED COMPOSITE ROTOR BLADE  
SPAR SPECIMENS

by  
D. Gleich

ARDE, INC.  
19 Industrial Avenue  
Mahwah, New Jersey 07430

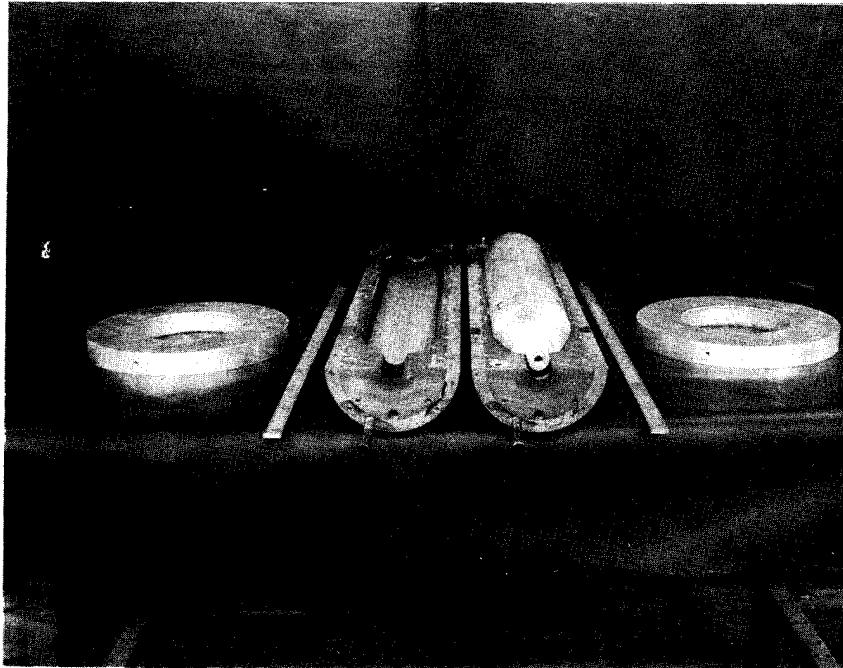
FIGURE 10

HYDROSTRETCH DIE

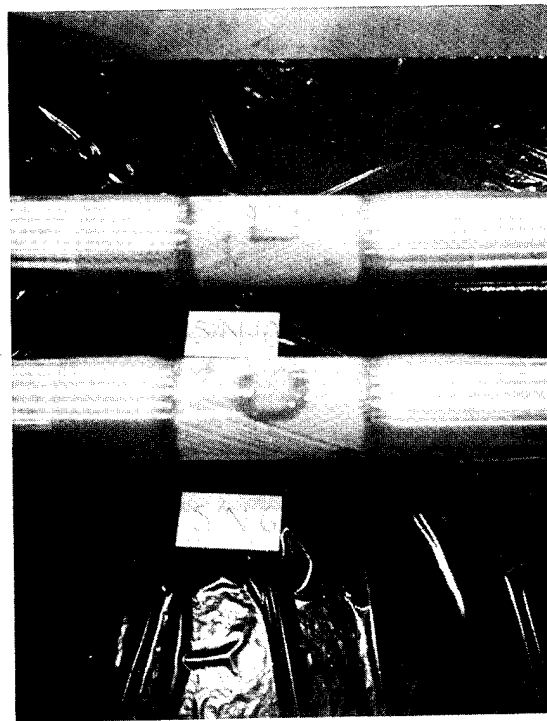
FIGURE 22  
COMPOSITE SPAR CRACK PROPAGATION TEST ASSEMBLY  
P/N E3866D S/N 6 & 10

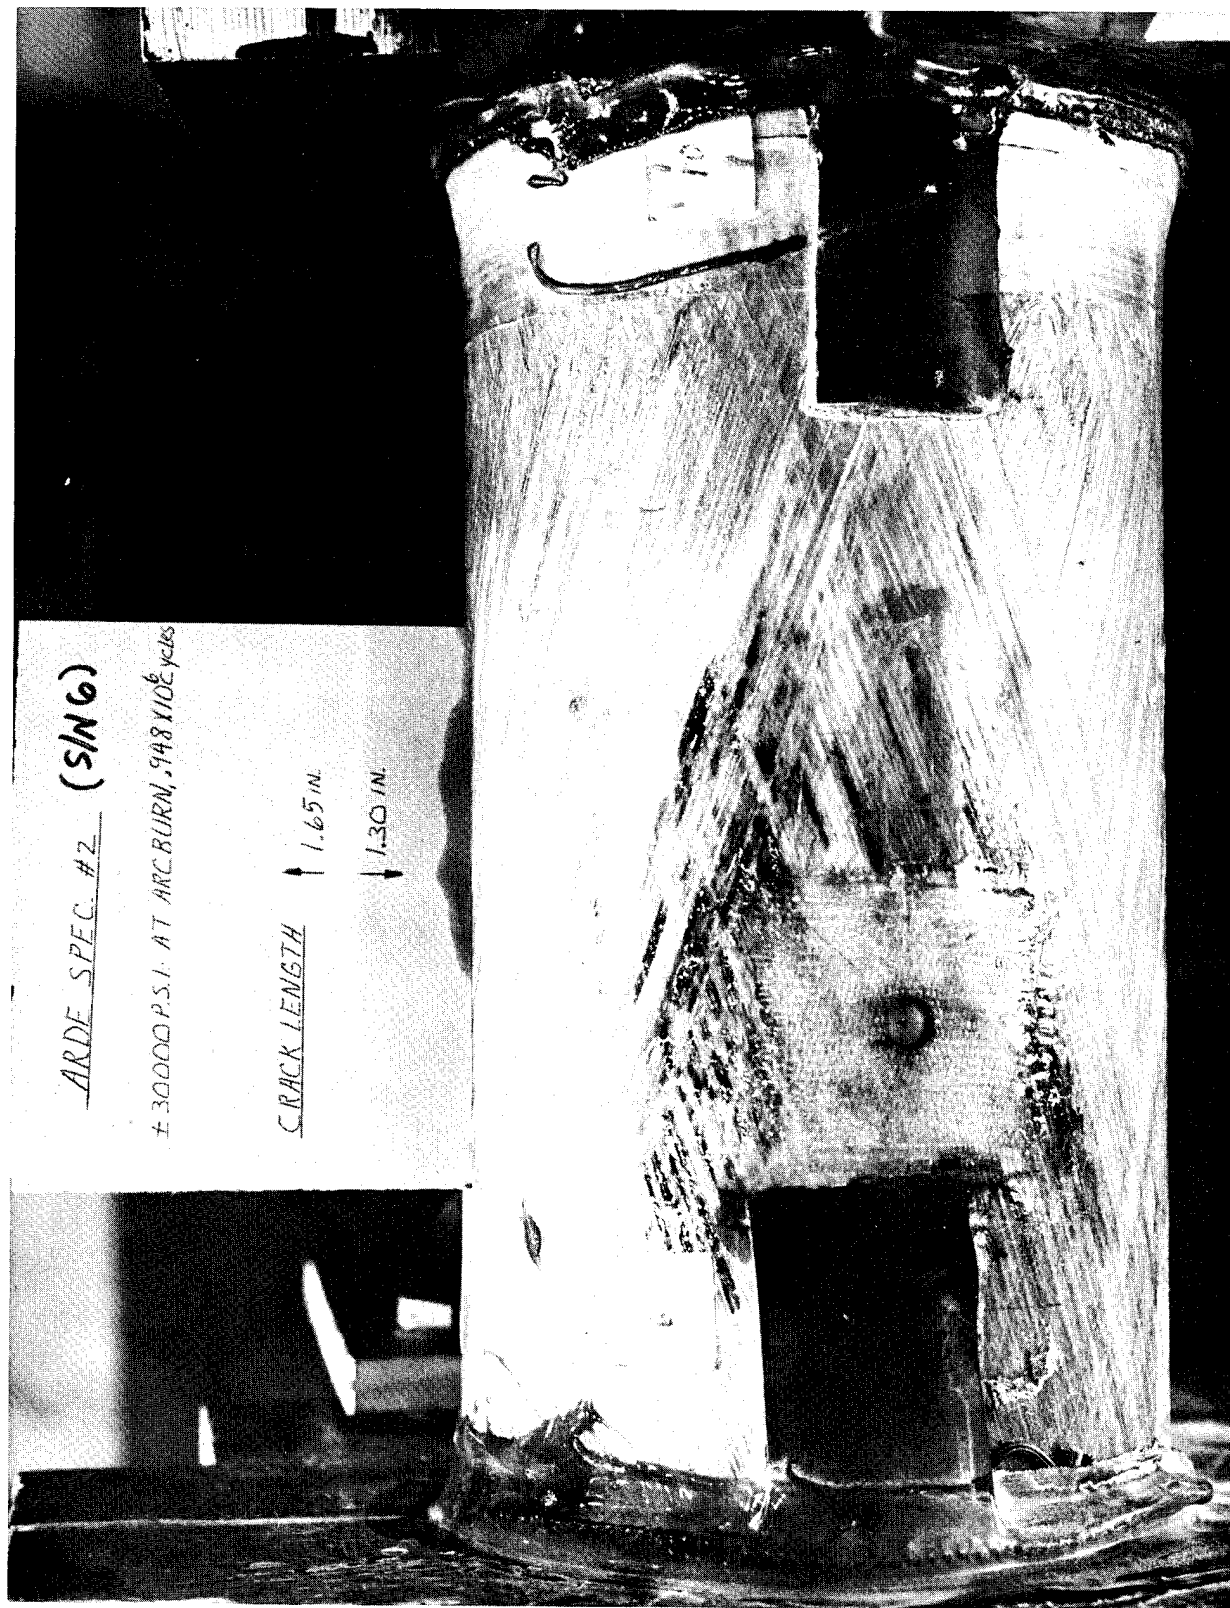
Figure 34 - SPECIMEN #2 IN CRACK PROGRESSION TEST

The alternating bending stress level at the crack station was applied in increments (starting with  $\pm 8.5$  ksi) for  $2 \times 10^6$  cycles each increment. Crack growth (if any) from the .14 inch long artificially induced fatigue crack was monitored. Table I lists the applied bending stress levels at the crack station versus cycles. No crack growth was noted at stress levels from  $\pm 8.5$  ksi to  $\pm 26.5$  ksi after  $16 \times 10^6$  cycles. Crack growth was finally observed at  $\pm 30$  ksi bending stress level at the arc burn station after about an additional  $10^5$  cycles. Testing was then continued at  $\pm 30$  ksi bending stress level for another  $7 \times 10^6$  cycles (for a total of more than  $23 \times 10^6$  cycles) before appreciable crack growth (12.4 inches) was noted. Crack propagation testing of S/N 6 specimen was terminated at this point although the prestressed composite spar was still intact and could still resist load. The crack growth curve at  $\pm 30$  ksi bending stress level is plotted on figure 33. Photographs of figures 34 and 35 show views of S/N 6 specimen during and after the crack propagation test at  $\pm 30$  ksi bending stress.
